# Technical Bulletin

Section Title: Body, Cab and Accessories  
 TSB No. TS 05 07013

**SUBJECT:** Special Coverage Extension for Specific Paint Peeling on Bumpers or Side Sill Guards

**MODEL(S):** Kizashi (A6B424) models produced in the Sagara plant

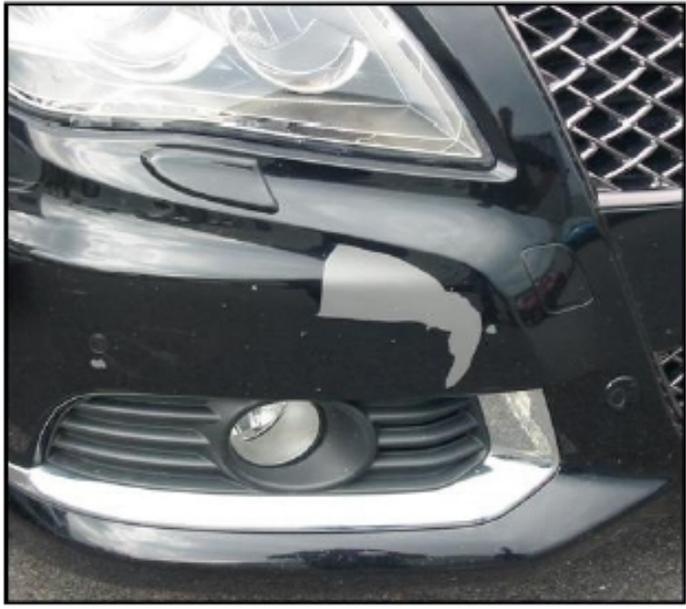
**Condition Example**

**CONDITION:** The primer coat may peel away from the bumpers or side sill guards.

**CAUSE:** Delays that occurred during the painting process created a deficient bond between the primer and the surface being painted.

**CORRECTION:** **DSPM inspection and authorization must be obtained prior to any repairs being performed.** A special coverage extension will apply for vehicles beyond the basic limited warranty limits. The coverage allows for either parts replacement and painting, or repainting of existing parts **after** inspection and documentation by a Suzuki Motor of America, Inc. DSPM. Repairs are to be carried out by a Suzuki Service Provider (only after DSPM inspection and approval) at no charge to the customer for parts and labor up to 9 years with unlimited mileage from the date the vehicle was sold to the retail owner or first placed in service as a demonstrator, whichever is earlier.

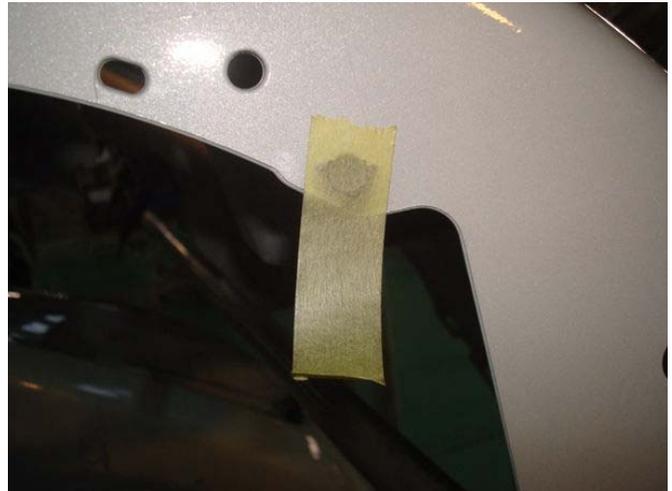
1. Apply the tape to the spot left by the clip during the painting process. The spot should be completely covered by the tape.

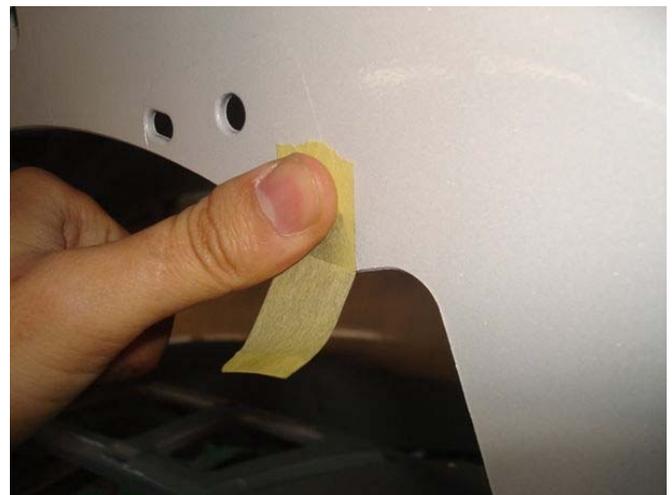
2. Remove any air bubbles and create maximum tape adhesion to the spot by rubbing the tape with your finger.

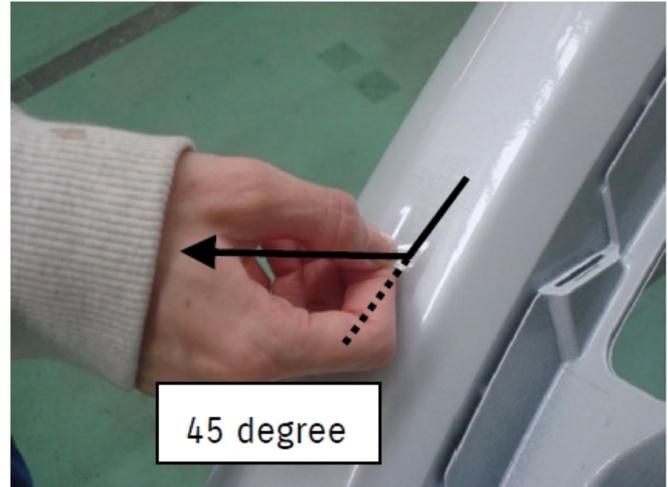
3. Remove the tape by pulling on it with a 45 degree angle between the tape and painted surface.

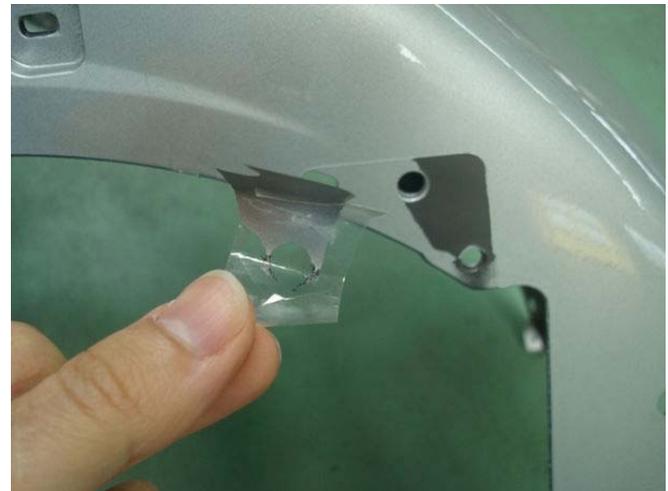
4. If the primer is lifted from the part by removing the tape, the part is affected.
  - a. Replace the affected part(s) with a new part(s).

- b. Repaint the affected part(s).

*In the case an existing part is to be repainted, the existing primer will have to be completely removed to provide sufficient bonding of the new primer to the part during the painting process.*

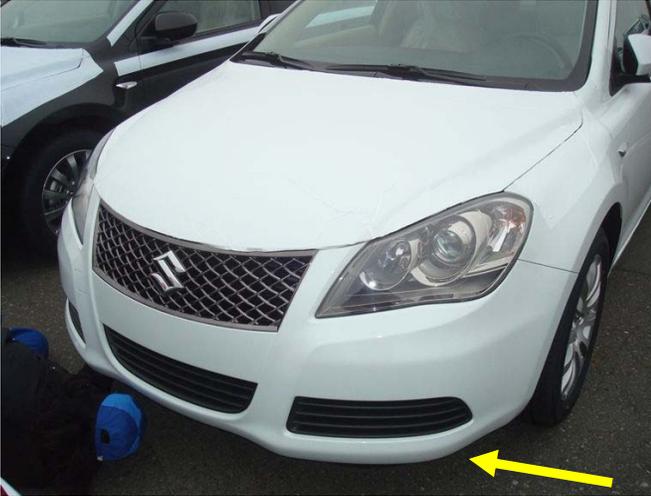
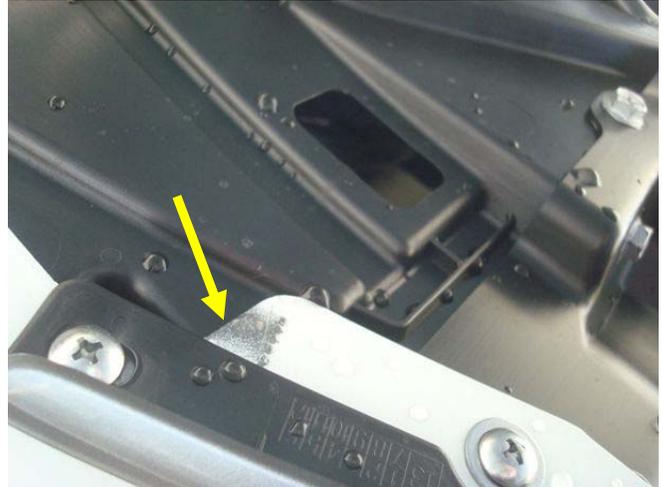
#### Kizashi Front Bumper

1. Located at the bottom left side.

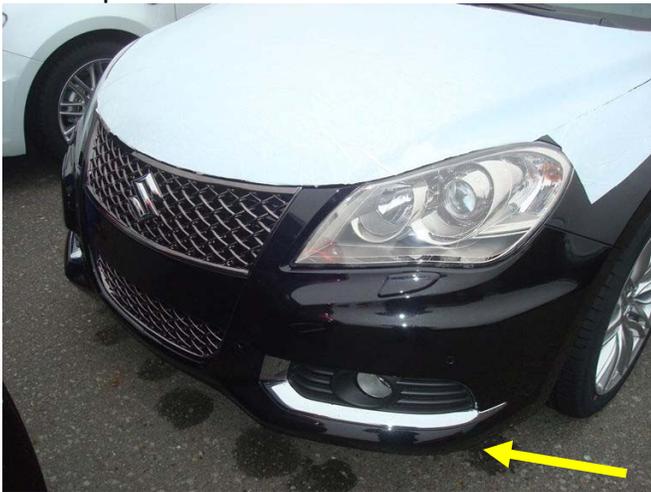
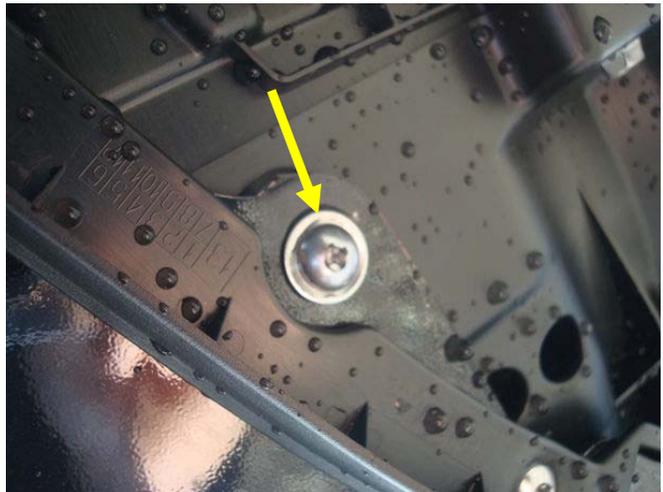
#### Kizashi Sport Front Bumper

1. Located at the bottom left side.
  - a. Remove the fastener to access the clip spot.

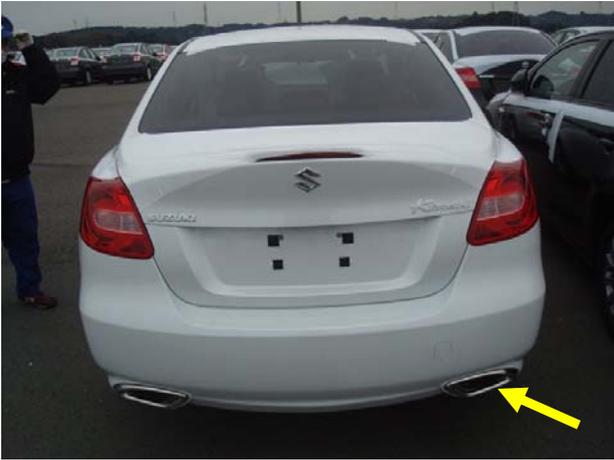
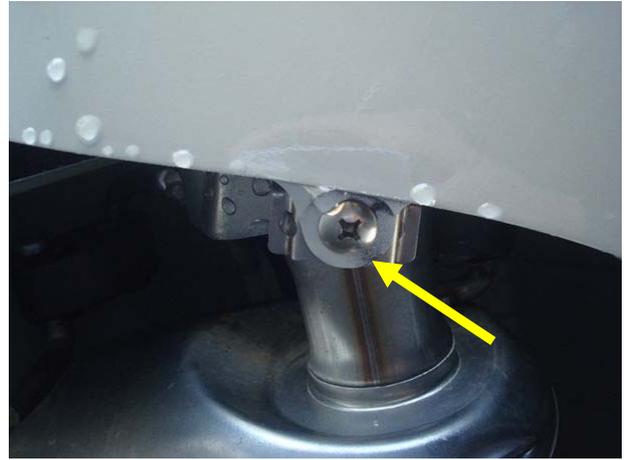
**Kizashi and Kizashi Sport Rear Bumper**

1. Located at the right side exhaust cover.
  - a. Remove the exhaust cover fastener to access the clip spot.

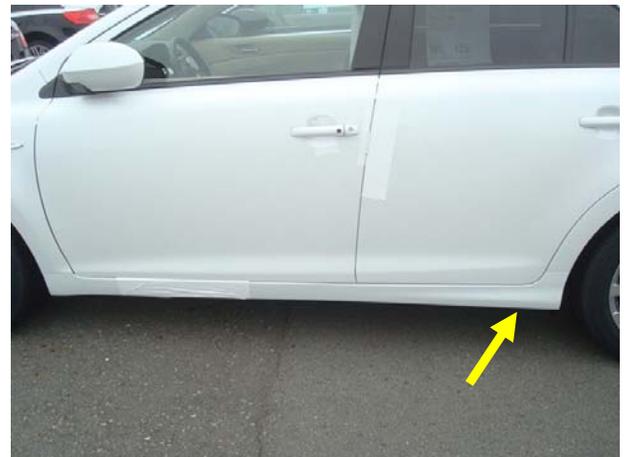
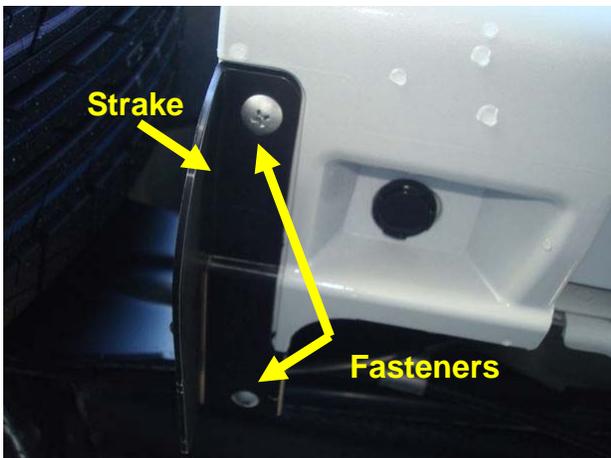
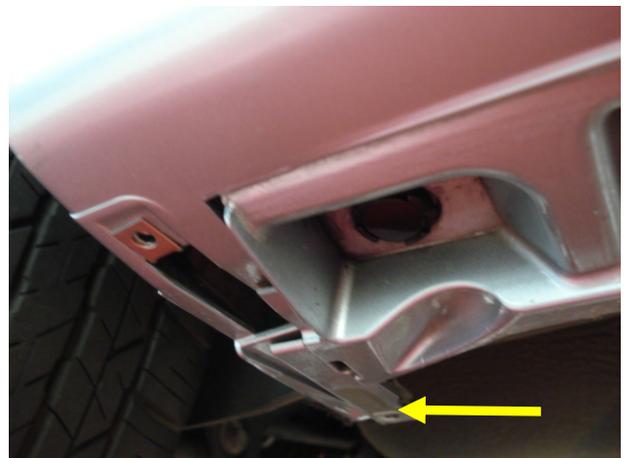
**Kizashi and Kizashi Sport Side Sill Guard**

1. Located at the rear bottom area of the left and right side sill guards.
  - a. Remove the strake to access the clip spot.
